## "Full" Reserve Study

### Lulu City Homeowners Association Teluride , CO

**Report #: 36806-0**  
**For Period Beginning: January 1, 2020**  
**Expires: December 31, 2020**

**Date Prepared: July 12, 2019**

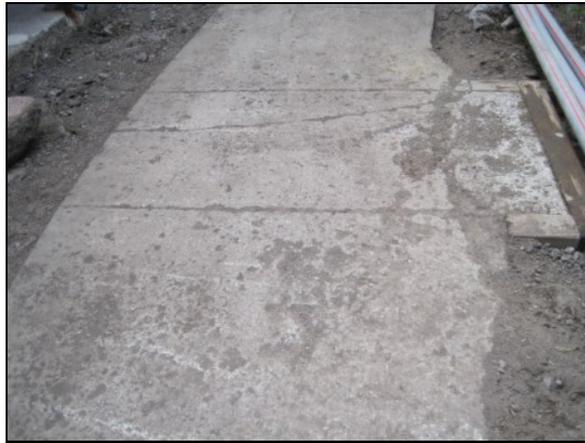
### Comp #: 2115 Concrete Walkways - Replace

Useful Life:  
5 years

Remaining Life:  
5 years

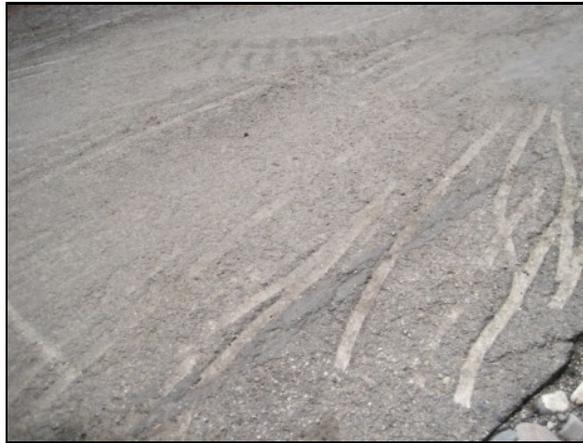
**Comp #: 2131 Asphalt - Seal/Repair**

Remaining Life:

4 years

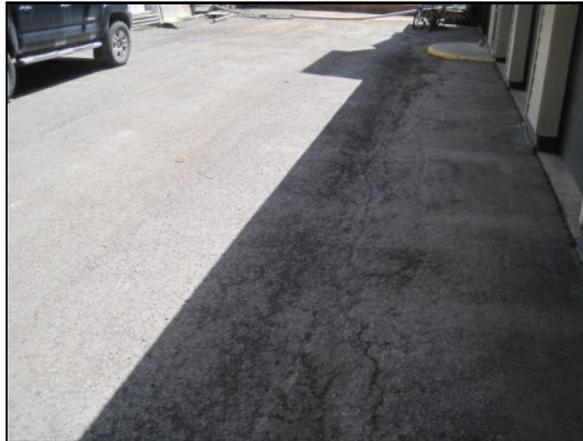
Useful Life:  
25 years

Remaining Life:  
0 years

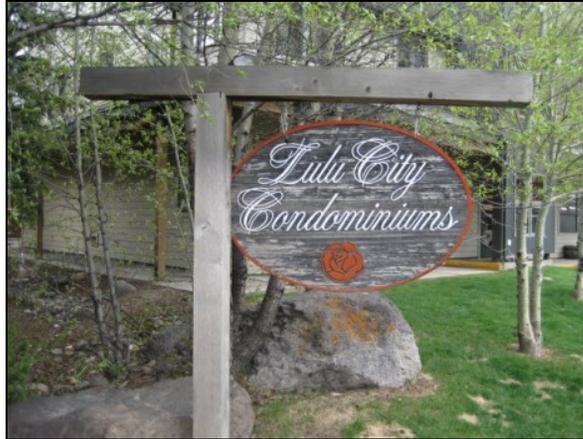
Useful Life:  
25 years

Remaining Life:  
12 years

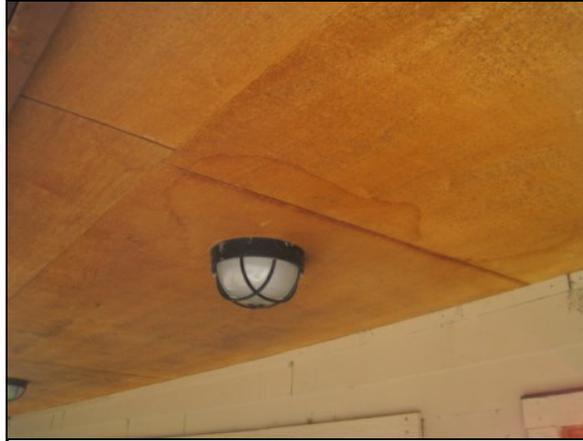
Useful Life:  
25 years

Remaining Life:  
12 years

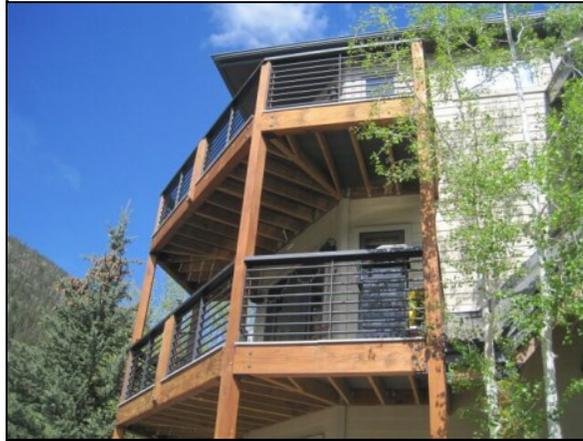
Useful Life:  
30 years

Remaining Life:  
17 years

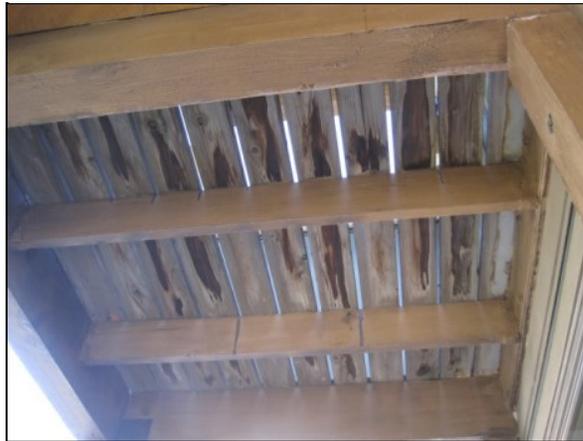
Useful Life:  
5 years

Remaining Life:  
0 years

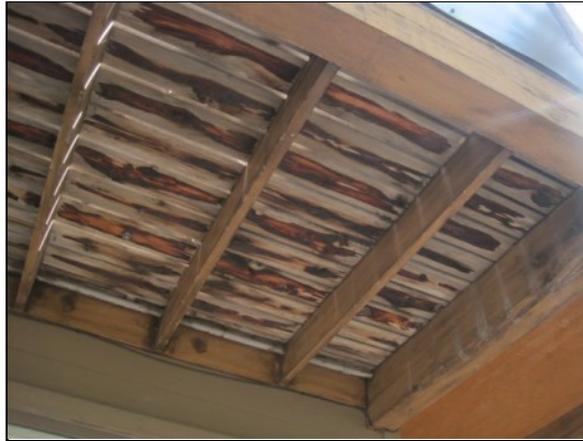
Useful Life:  
25 years

Remaining Life:  
12 years

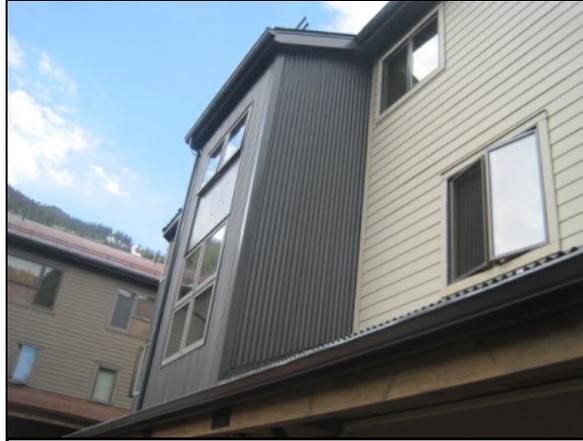
Useful Life:  
7 years

Remaining Life:  
2 years

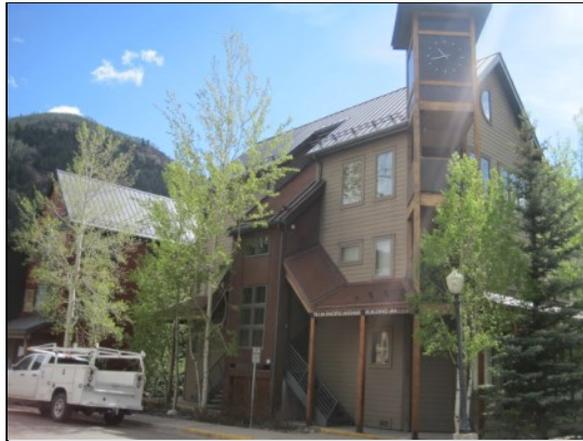
Useful Life:  
50 years

Remaining Life:  
37 years

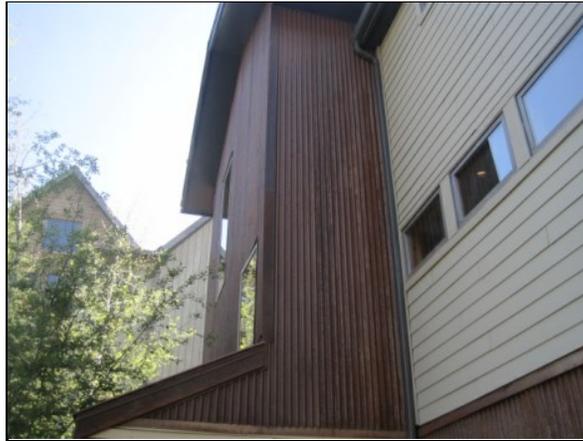
Useful Life:  
50 years

Remaining Life:  
37 years

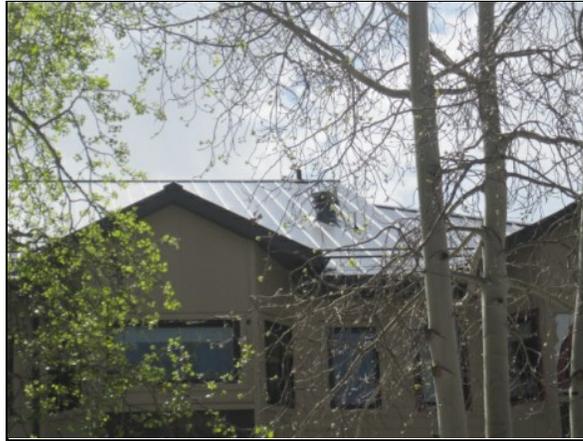
Useful Life:  
40 years

Remaining Life:  
27 years

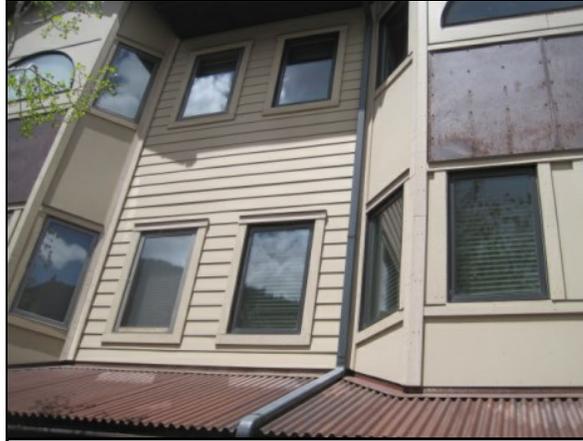
Useful Life:  
40 years

Remaining Life:  
27 years

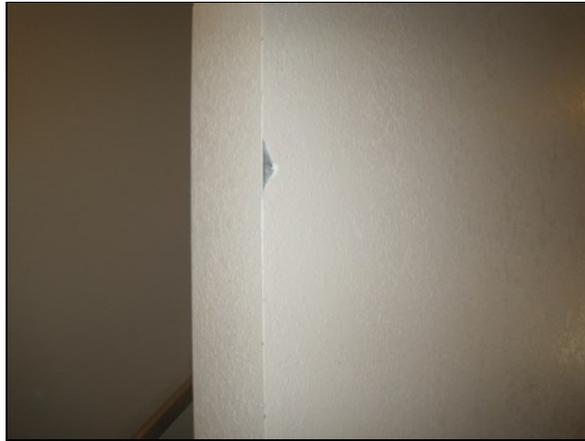
Useful Life:  
15 years

Remaining Life:  
1 years

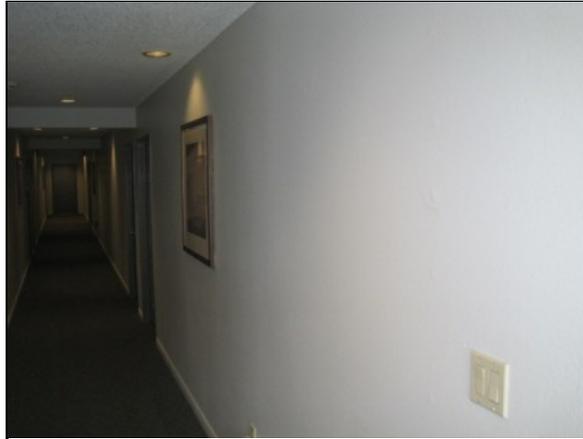
Useful Life:  
15 years

Remaining Life:  
13 years

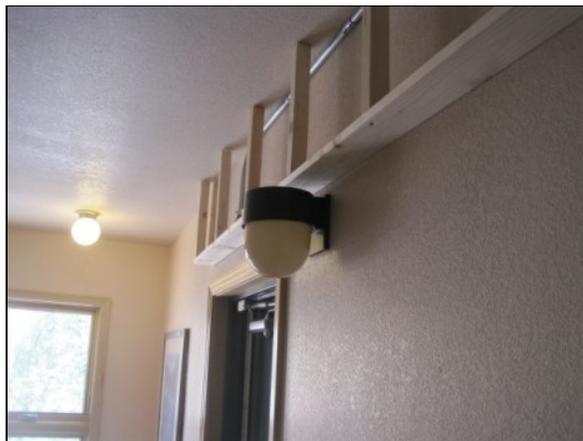
Useful Life:  
25 years

Remaining Life:  
12 years

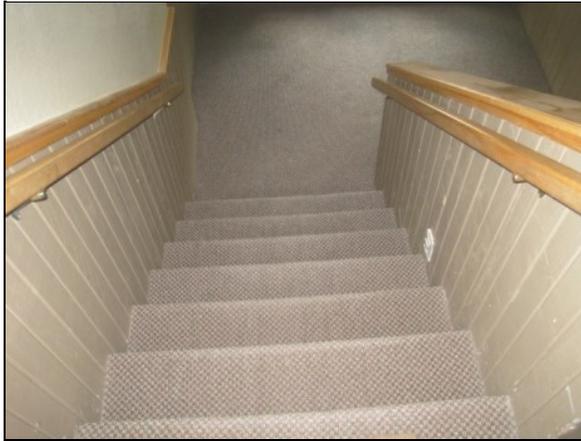
Useful Life:  
15 years

Remaining Life:  
1 years

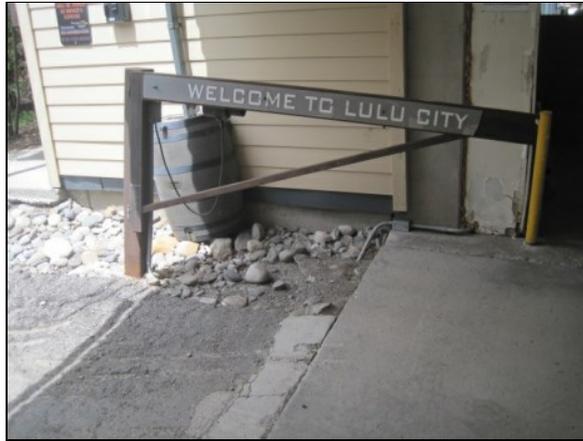
Useful Life:  
10 years

Remaining Life:  
2 years

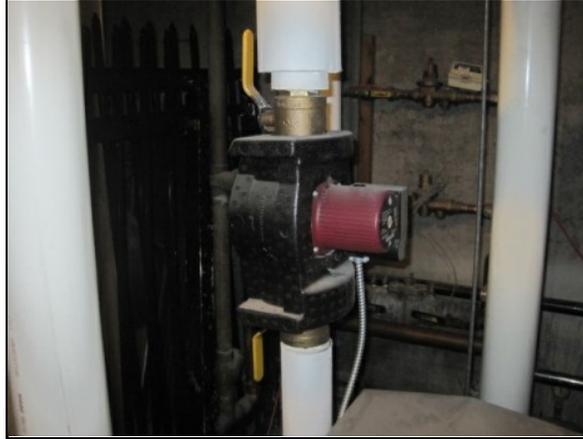
Useful Life:  
15 years

Remaining Life:  
7 years

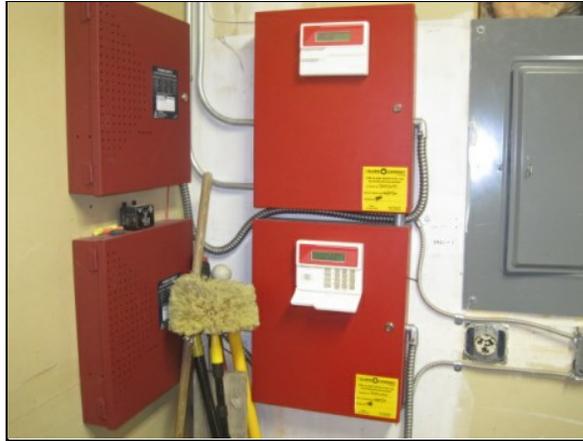
Useful Life:  
20 years

Remaining Life:  
5 years

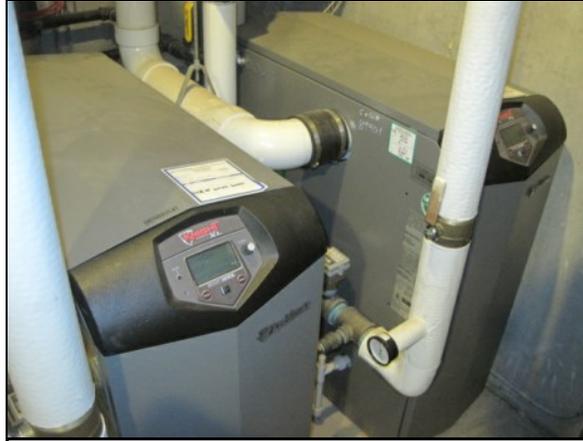
Useful Life:  
25 years

Remaining Life:  
17 years

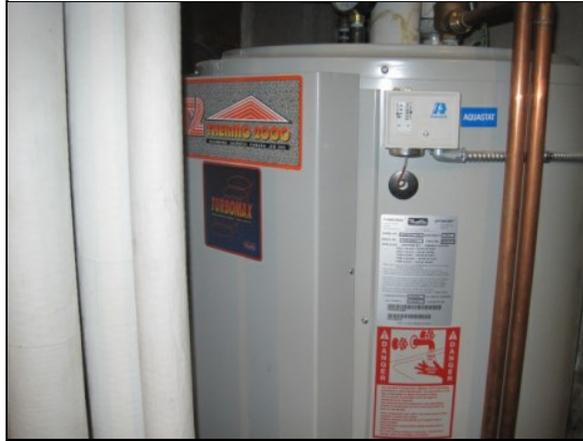
Useful Life:  
30 years

Remaining Life:  
22 years

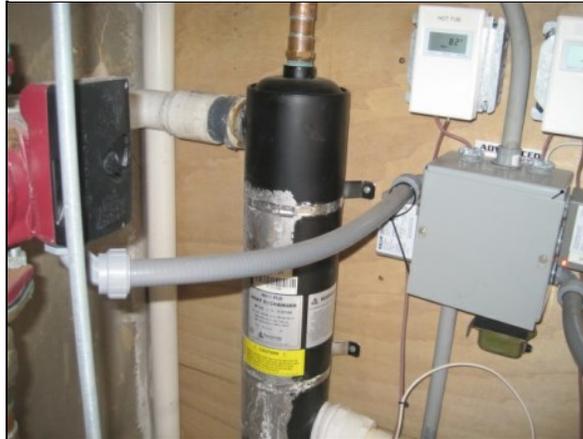
Useful Life:  
20 years

Remaining Life:  
16 years

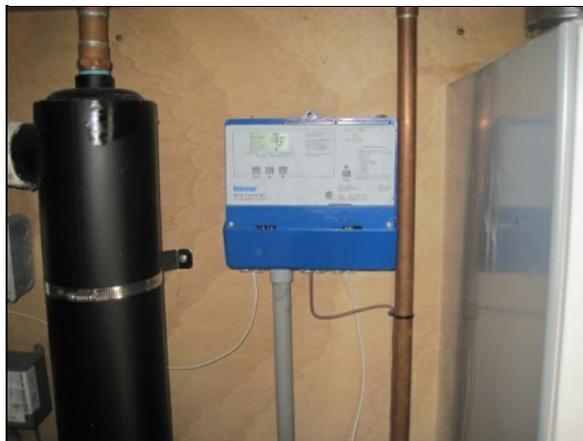
Useful Life:  
10 years

Remaining Life:  
0 years

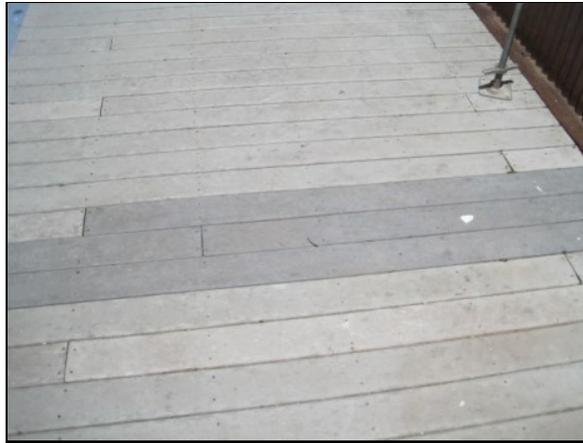
Useful Life:  
25 years

Remaining Life:  
8 years

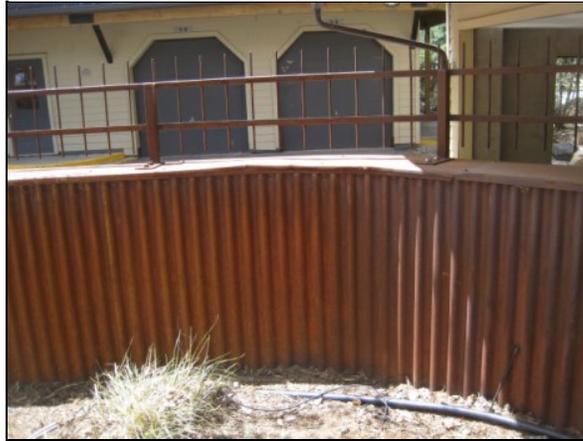
Useful Life:  
30 years

Remaining Life:  
17 years

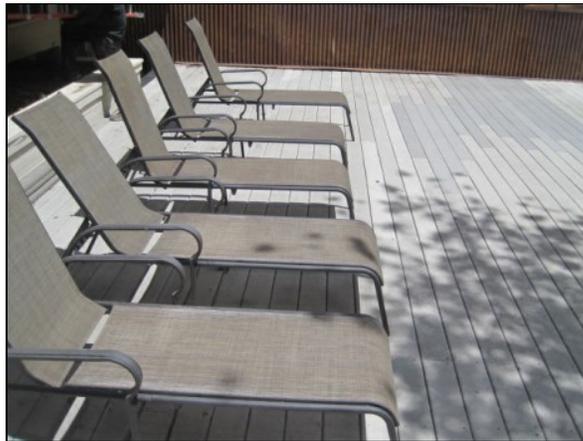
Useful Life:  
10 years

Remaining Life:  
5 years

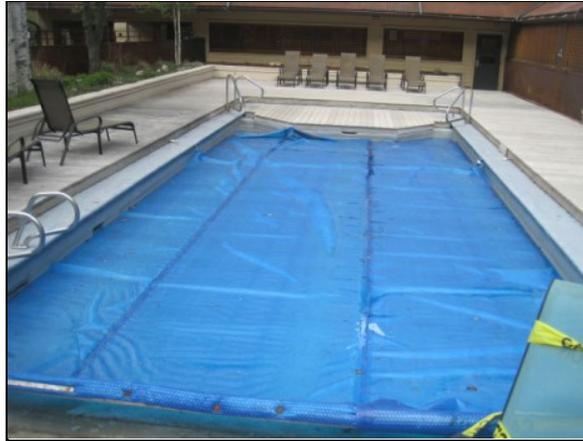
Useful Life:  
15 years

Remaining Life:  
2 years

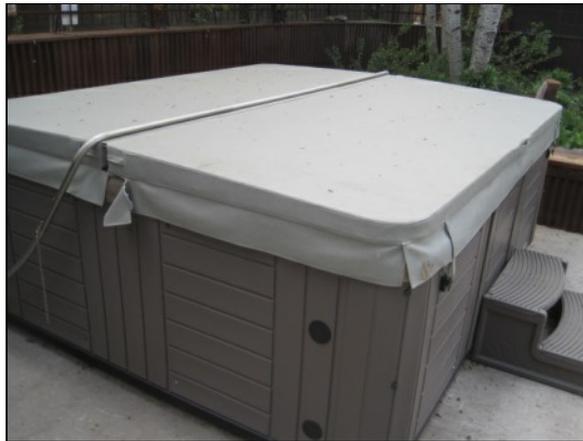
Useful Life:  
15 years

Remaining Life:  
11 years

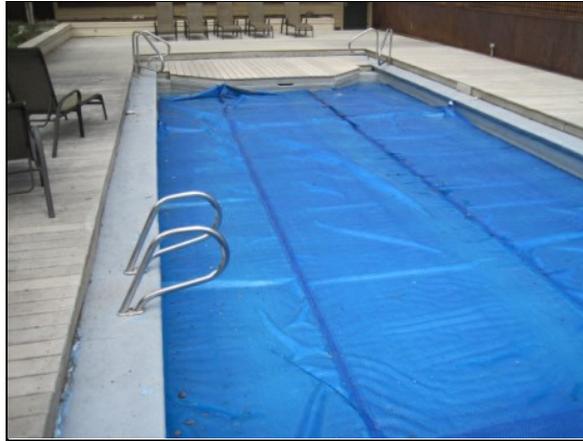
Useful Life:  
8 years

Remaining Life:  
7 years

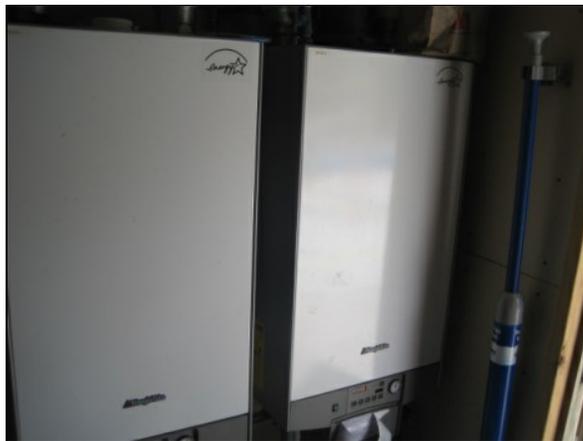
Useful Life:  
12 years

Remaining Life:  
0 years

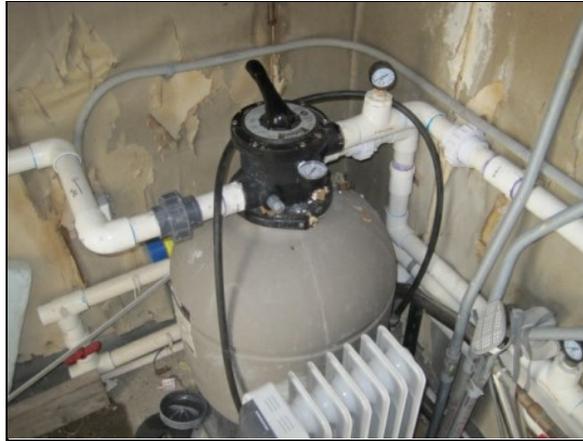
Useful Life:  
20 years

Remaining Life:  
7 years

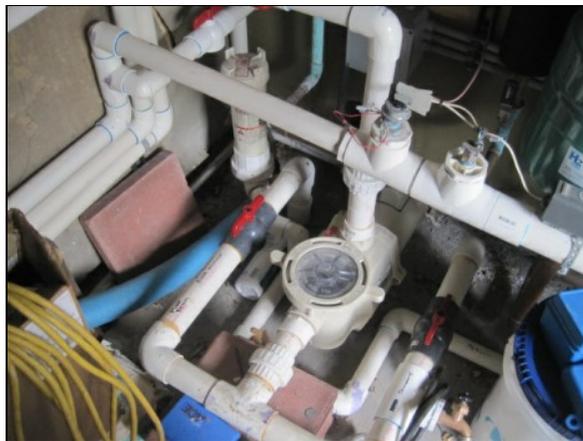
Useful Life:  
12 years

Remaining Life:  
4 years
